SOLENO
SERVICE : Expertise
: and solutions

REHABILITATION OF A BRICK MANHOLE BY SPRAYED EPOXY APPLICATION IN DOWNTOWN VICTORIANVILLE

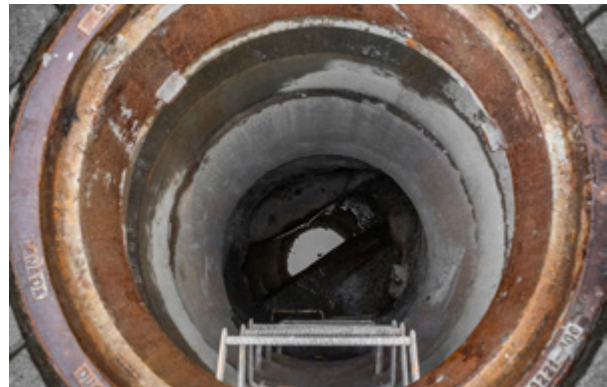
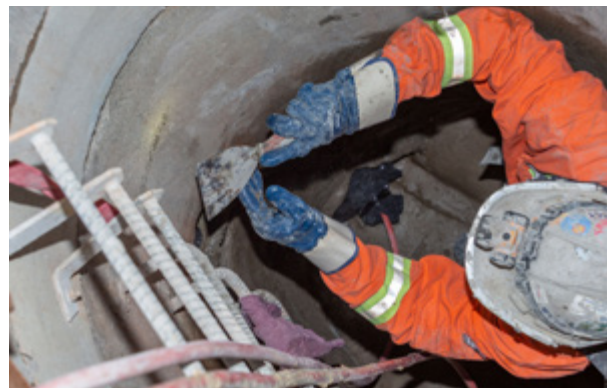
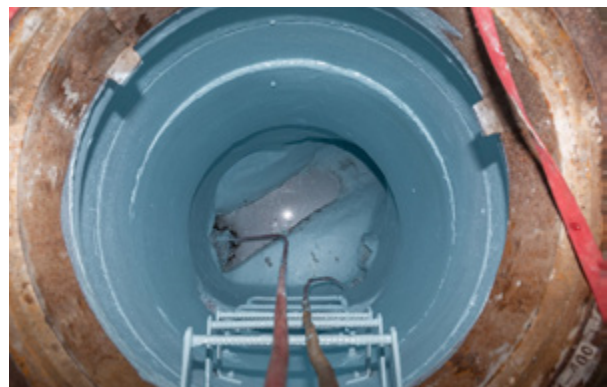
The brick manhole to rehabilitate, measuring 900 mm (36 in) diameter, had several failures: presence of smelly stagnant water, absence benching and drainage at the bottom, eroded lower brick walls and concrete restored upper walls now degraded and decayed. The infrastructure rehabilitation service by epoxy spraying was selected as the best solution for the rehabilitation of this brick manhole.

Soleno Service's team prepared the surface to rehabilitate by first cleaning it, to ensure it was free of any contaminant. Then, cracks were sealed, and surface unevenness was corrected with Solhydroc brand cementing products. The technicians of Soleno Service also created a benching in order to address its absence and rebuilt the crowns who were heavily eroded and degraded. Once the profiles were restored, a layer of SSR-175 primer and epoxy sealant was applied, to ensure good adhesion of the SSR-405 epoxy coating. This volatile organic compound (VOC) free is composed of 100% solids (no shrinkage). The application of 3.05 mm (120 mils) of SSR-405 epoxy, with a Graco XP50 multi-component airless spraying system, completed this rehabilitation carried out in November 2018.
