WE ENSURE  
**PERFORMANCE**  
OF UNDERGROUND INFRASTRUCTURES

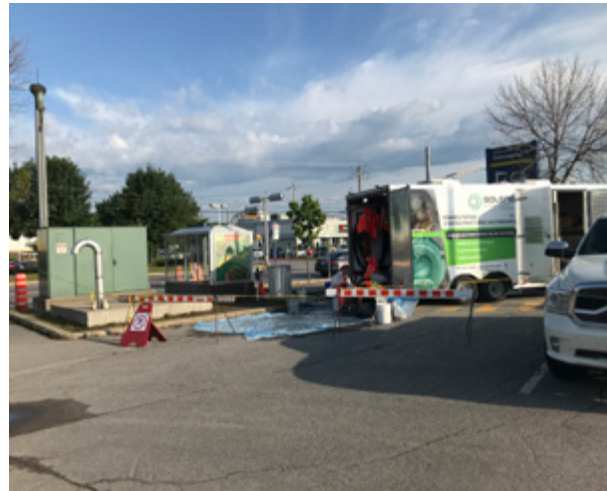
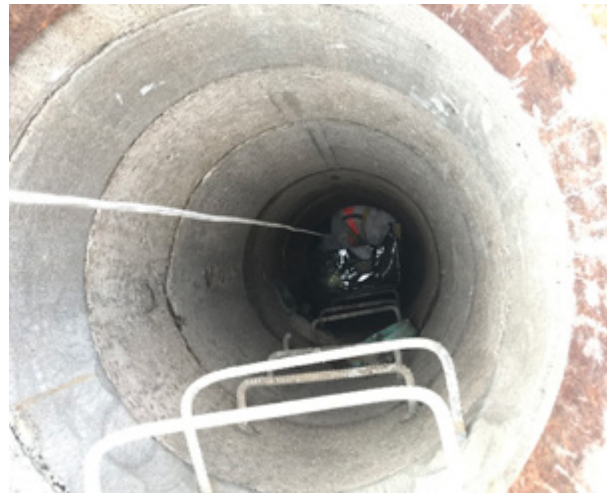
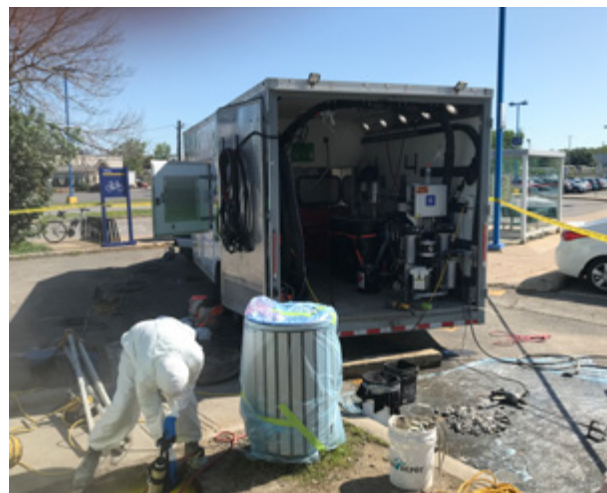
The concrete manhole to be rehabilitated, 900 mm (36 in) in diameter, had several deficiencies: absence benching and flow at the bottom, degraded and cracked walls and seals and a high groundwater table amplified all the problems. The infrastructure rehabilitation solution using epoxy and polyurea spray was selected as the best solution for the rehabilitation of this 6-meters (19.6-foot) high concrete manhole.

The Soleno Service team prepared the surface to be rehabilitated by first cleaning it extensively to ensure that it was free of any contaminants. Then, the many cracks were filled by injections, and the irregularities in the manhole profile were corrected with Solhydroc brand cementitious products. Soleno Service technicians also created a benching to remedy the bottom flow problem and waterproofed the crowns that were severely eroded and degraded. Once the profiles were restored, a coat of SSR-175 primer and epoxy sealant was applied to ensure good adhesion of the coatings and to counter the degasification phenomenon associated with concrete. Subsequently, the Soleno Service team applied 3.175 mm (125 mils) of SSR-405 epoxy coating using a Graco XP50 multi-component airless spray system. This product does not contain volatile organic compounds (VOCs) and is composed of 100% solids (no shrinkage). Finally, the application of 2.54 mm (100 mils) of SSR-581 flexible polyurea to the last section of the manhole completed this rehabilitation which was done in August 2019. The elongation up to 614% of the SSR-581 restores waterproofing to the structures while maintaining its flexibility, thus allowing to withstand freeze/thaw cycles. To confirm that the work was done properly, a spark test was carried out.

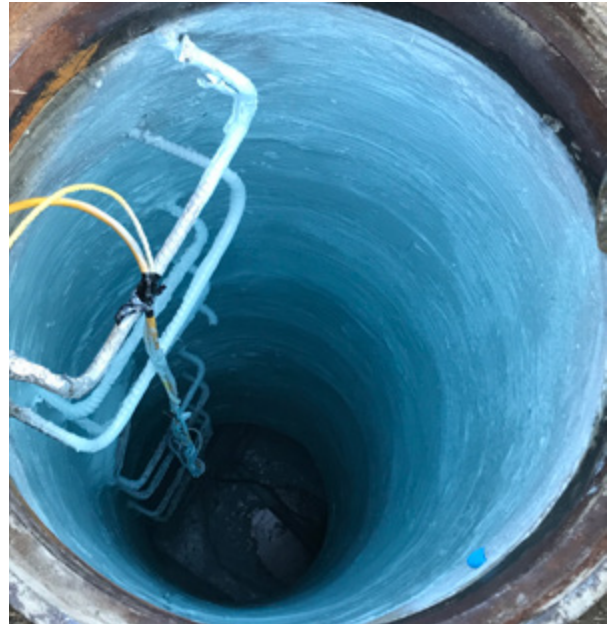
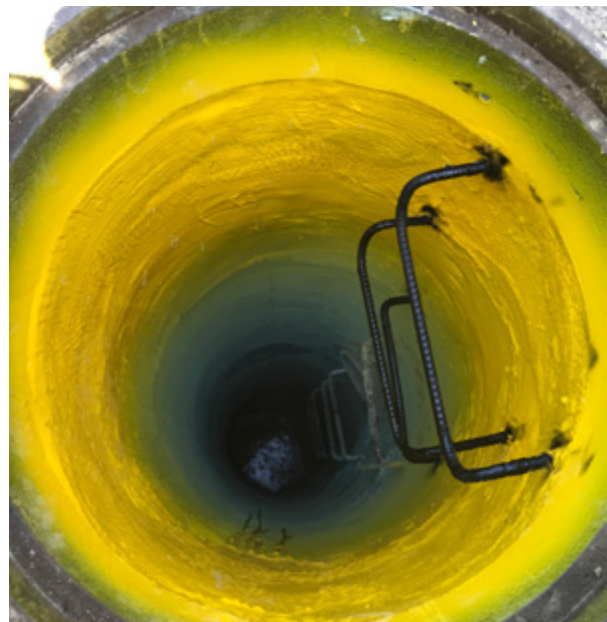
Using a spraying epoxy and polyurea method for the rehabilitation of underground infrastructures was the ideal solution to solve this particular problem for the City of Châteauguay. Indeed, this rehabilitation made it possible to eliminate the extraneous water that entered the network directly through this defective manhole. It also allowed the pumping station to be more efficient by returning to a normal daily volume of wastewater, allowing the pumps in place to return to a normal operating mode by halving their use, thereby reducing energy costs.

By eliminating the daily volume of extraneous water of 140 m<sup>3</sup> (4944 ft<sup>3</sup>), the rehabilitation of this manhole allows the City of Châteauguay to go ahead with a residential project of about 100 single-family homes or their equivalent on its territory, a project that was not feasible before the rehabilitation work of Soleno Service.
