SOLENO

THE ONLY SOLUTION WAS
POLYETHYLENE (HDPE)

Culvert replacement on the Rouge river at Laframboise Blvd. in Saint-Hyacinthe

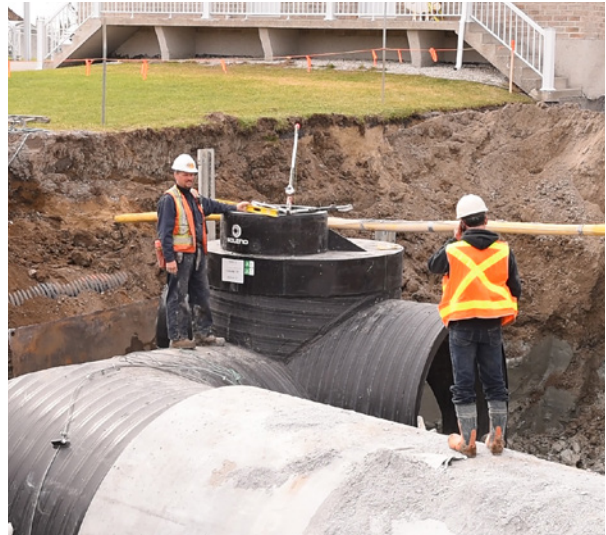
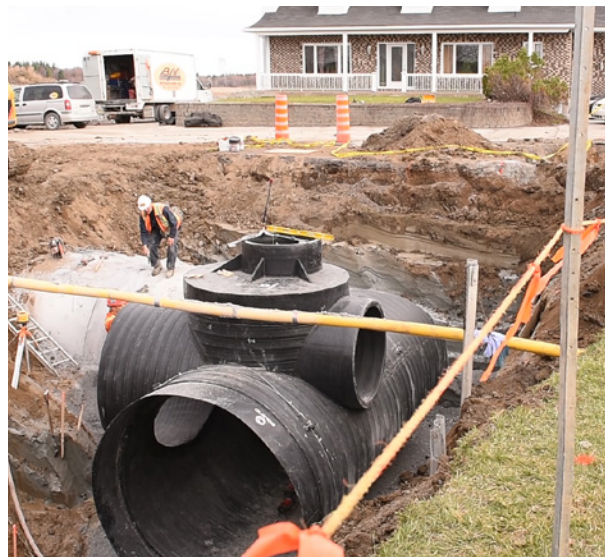
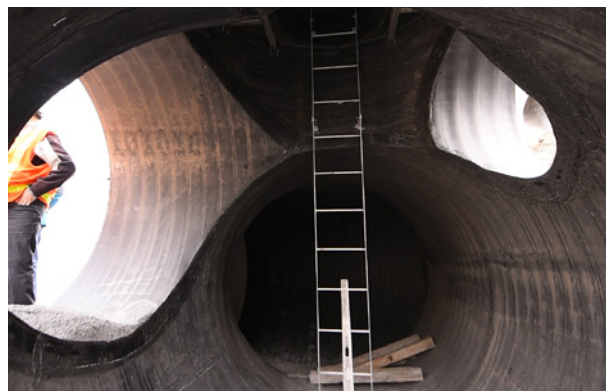
HDPE was considered the best solution for the culvert replacement. The water stream was changed in order to facilitate its flow during intense rain events. The first elbow allowed the connection of the new pipe 2100 mm (82 in) in diameter, the new 2400 mm (95 in) culvert, an existing storm water pipe 1500 mm (60 in) in diameter made of corrugated and galvanized steel pipes (CSP) and an existing pipe to be evaluated on site. The second elbow allowed the return of the 2400 mm (95 in) pipe in the existing river bed, while connecting the piped storm sewer that ran along the road.

As Laframboise Blvd. is a major artery in Saint-Hyacinthe, construction time had to be as short as possible. The work was carried out in 12 days. Unlike concrete structures that have to be cast in place, HDPE structures could be manufactured, which has reduced construction time. In addition, unlike traditional concrete manholes, HDPE manholes require no oversizing, which allowed the reduction by half of the manhole diameter, in spite of existing larger diameter pipes. This solution has resulted in substantial savings in acquisition, excavation and installation, other key benefits of using HDPE.
