SOLENO
SERVICE : Expertise
: and solutions

THE REHABILITATION OF A CONCRETE MANHOLE WILL ALLOW THE CITY OF CHÂTEAUGUAY TO EXPAND ITS INDUSTRIAL PARK

Thanks to an economical solution and without excavation, the Saint-Jean-Baptiste pumping station has regained an acceptable daily wastewater flow rate.

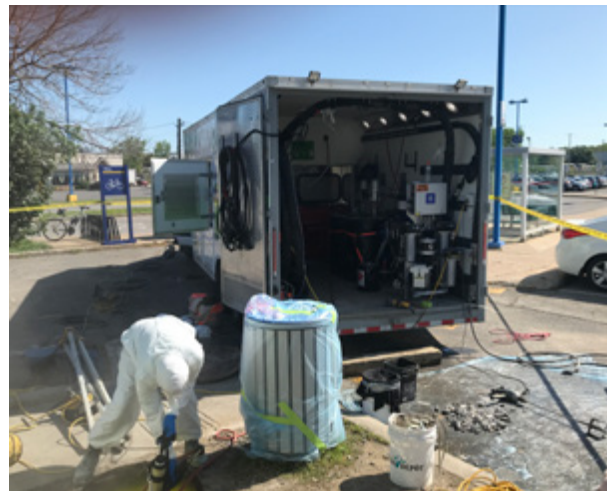
The concrete manhole to be rehabilitated, 900 mm (36 in) in diameter, had several deficiencies: absence benching and flow at the bottom, degraded and cracked walls and seals and a high groundwater table amplified all the problems. The infrastructure rehabilitation solution using epoxy and polyurea spray was selected as the best solution for the rehabilitation of this 6-meters (19.6-foot) high concrete manhole.

The Soleno Service team prepared the surface to be rehabilitated by first cleaning it extensively to ensure that it was free of any contaminants. Then, the many cracks were filled by injections, and the irregularities in the manhole profile were corrected with Solhydroc brand cementitious products. Soleno Service technicians also created a benching to remedy the bottom flow problem and waterproofed the crowns that were severely eroded and degraded. Once the profiles were restored, a coat of SSR-175 primer and epoxy sealant was applied to ensure good adhesion of the coatings and to counter the degasification phenomenon associated with concrete. Subsequently, the Soleno Service team applied 3.175 mm (125 mils) of SSR-405 epoxy coating using a Graco XP50 multi-component airless spray system. This product does not contain volatile organic compounds (VOCs) and is composed of 100% solids (no shrinkage). Finally, the application of 2.54 mm (100 mils) of SSR-581 flexible polyurea to the last section of the manhole completed this rehabilitation which was done in August 2019. The elongation up to 614% of the SSR-581 restores waterproofing to the structures while maintaining its flexibility, thus allowing to withstand freeze/thaw cycles. To confirm that the work was done properly, a spark test was carried out.
