## REHABILITATION OF CULVERT WITH KRAH HIGH-DENSITY POLYETHYLENE (HDPE) PIPE

### A cost-effective Solution for Culvert Restoration in the Niagara Region

# REHABILITATION PROCESS OF CULVERT WITH KRAH HIGH-DENSITY POLYETHYLENE (HDPE) PIPE

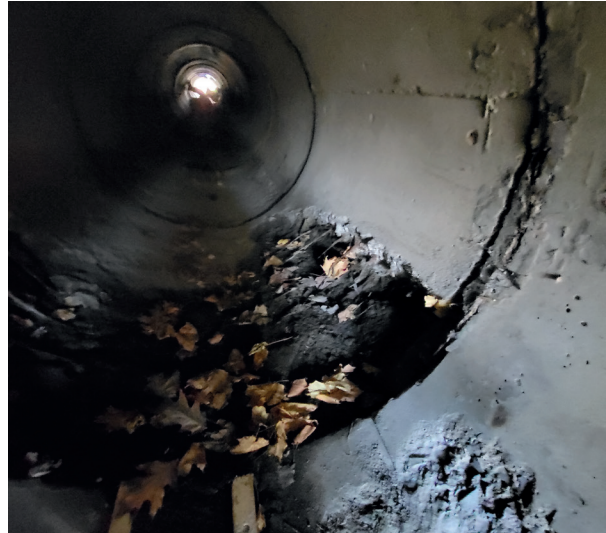
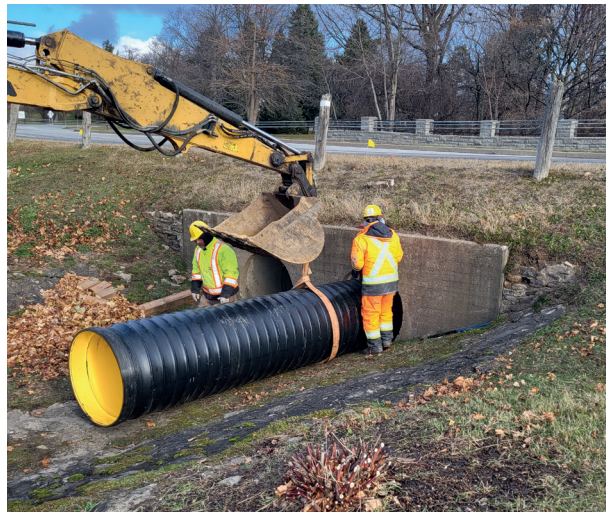
Signs of wear and structural compromise had become evident in the existing concrete culverts within the Niagara region. Issues such as loose joints, loss of strength, corrosion and rebar exposure necessitated attention to ensure the continued functionality and structural integrity of these essential infrastructure elements.

To meet the project's requirements, Soleno's technical service recommended a high-density polyethylene (HDPE) pipe: the Krah pipe, with smooth interior and exterior walls. This pipe made it possible to rehabilitate the 2 existing culverts with a waterproof, economical and large diameter relining.

Two Krah pipes with an inside diameter of 800 mm and an outside diameter of 902 mm, were selected. The combined length of the installed pipes was 65 meters. The decision to use Krah pipes was based on their functionality, life cycle costs, and environmental impact considerations.
