CULVERT REHABILITATION WITH KUSTOMFLO HIGH-DENSITY POLYETHYLENE (HDPE) PIPE

A cost-effective Solution for Culvert Restoration in the Niagara Region

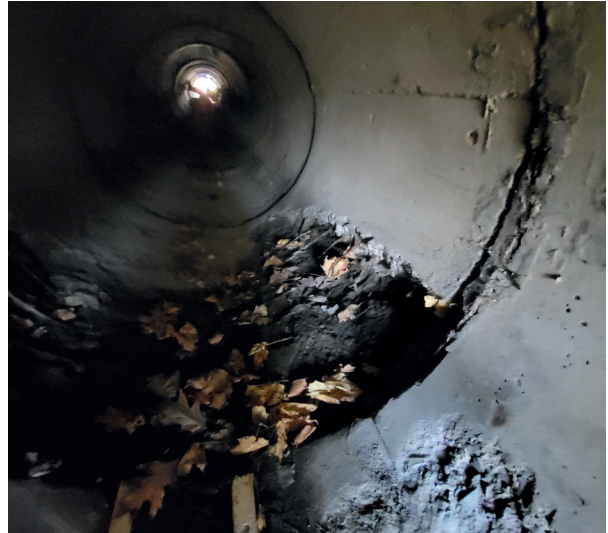
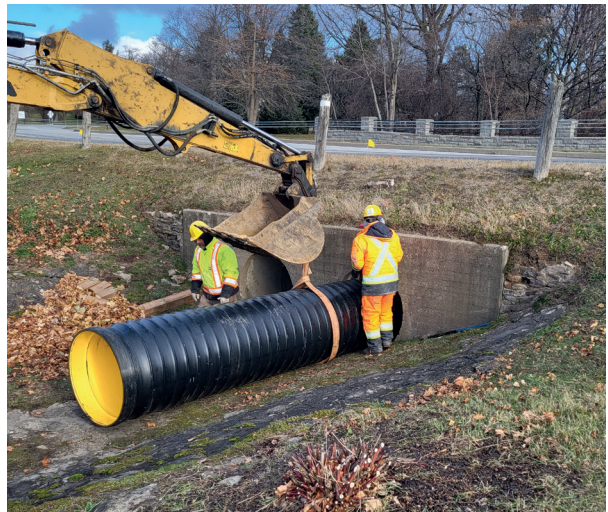
Signs of wear and impact on structural integrity in the existing concrete culvert within the Niagara region had become obvious. Issues such as loose joints, resistance loss, corrosion and rebar exposure required a dedicated attention to ensure the continued functionality and structural integrity of these essential infrastructure components.

To meet the project's requirements, Soleno's technical service recommended a high-density polyethylene (HDPE) pipe: the KustomFlo pipe, with smooth interior and exterior walls. This pipe made it possible to rehabilitate the 2 existing culverts with a waterproof, cost-efficient and large diameter relining.

Two KustomFlo pipes with an inside diameter of 800 mm and an outside diameter of 902 mm, were selected. The combined length of the installed pipes was 65 metres. The decision to use KustomFlo pipes was based on their functionality, life cycle costs, and environmental impact considerations.
